Application- Komatsu PC1250SP Track Bolts

PneuTorque® PTM Multiplier + Standard Reaction

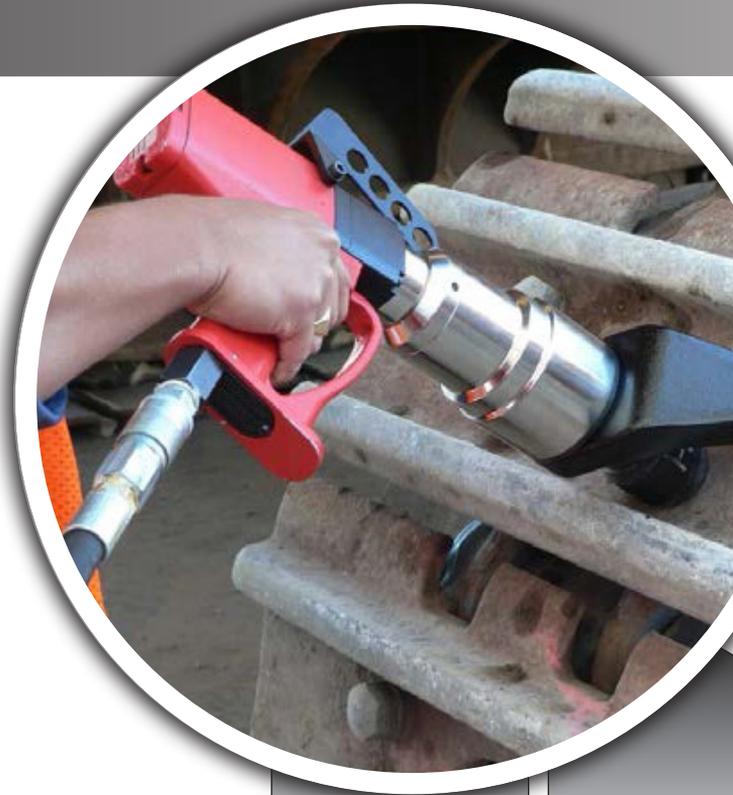
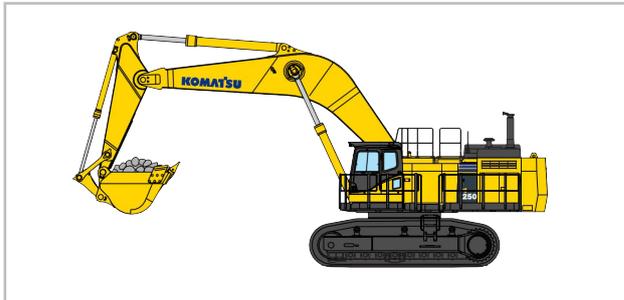
Solution: PneuTorque® PTM 119 4500 N·m torque multiplier with standard supplied reaction plate. The tool delivered much improved torque control, increasing the life of hardware and providing the company with productivity gains. The non-impacting nature of the tool helped reduce the chances of operator injury and was far better for the fasteners, making it the tool of choice amongst their maintenance teams.

Problem: A civil engineering company were experiencing failures with tracks bolts coming loose drastically effecting the vehicles ability to move about the site. Some bolts had loosened off causing miss alignment of the tracks and further issues with surrounding hardware. Resultant damage was caused by use of a impact wrench and slogging spanner offering inadequate torque control.
